Debris/Ice/TPS Assessment And Photographic Analysis For Shuttle Mission STS-48

November 1991

Gregory N. Katnik
NASA/Kennedy Space Center

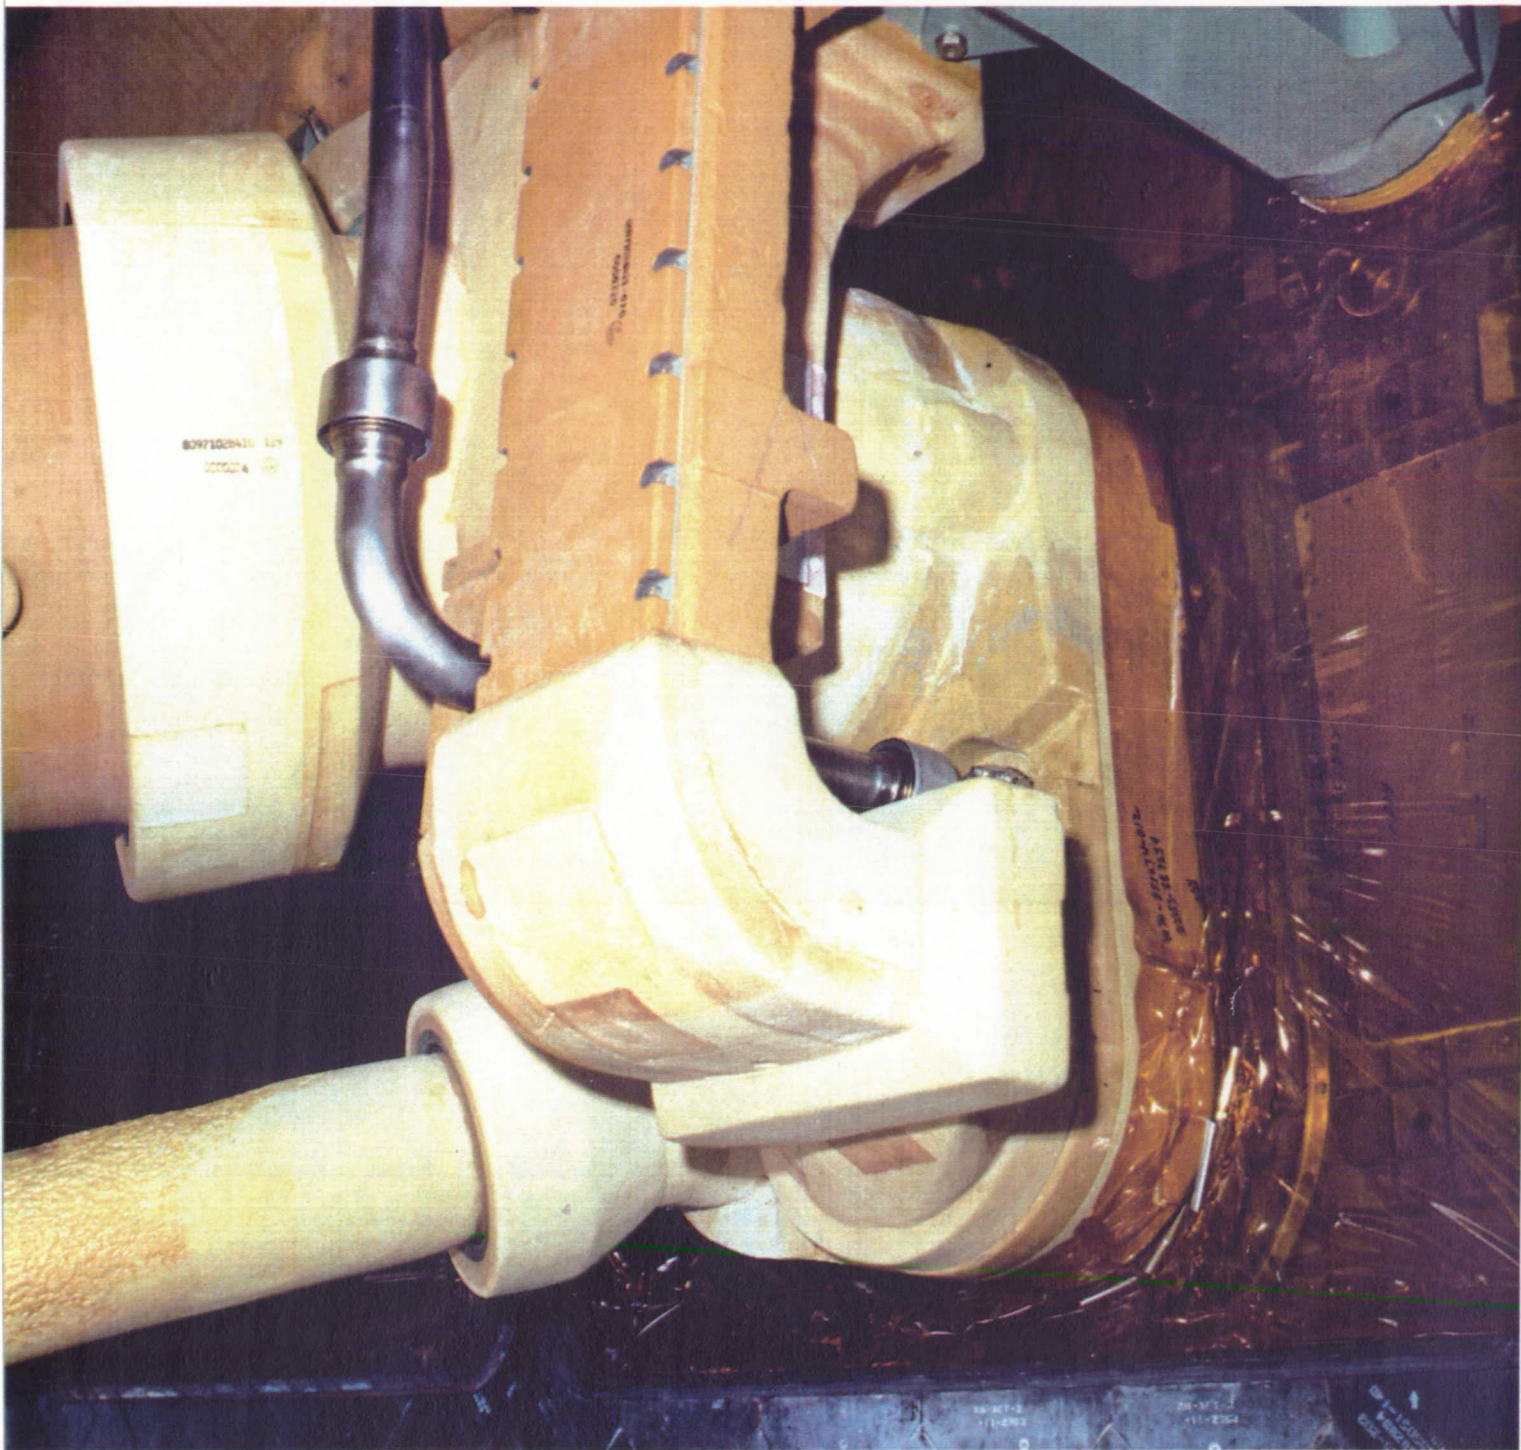
Overall view of the LH2 ET/ORB umbilical

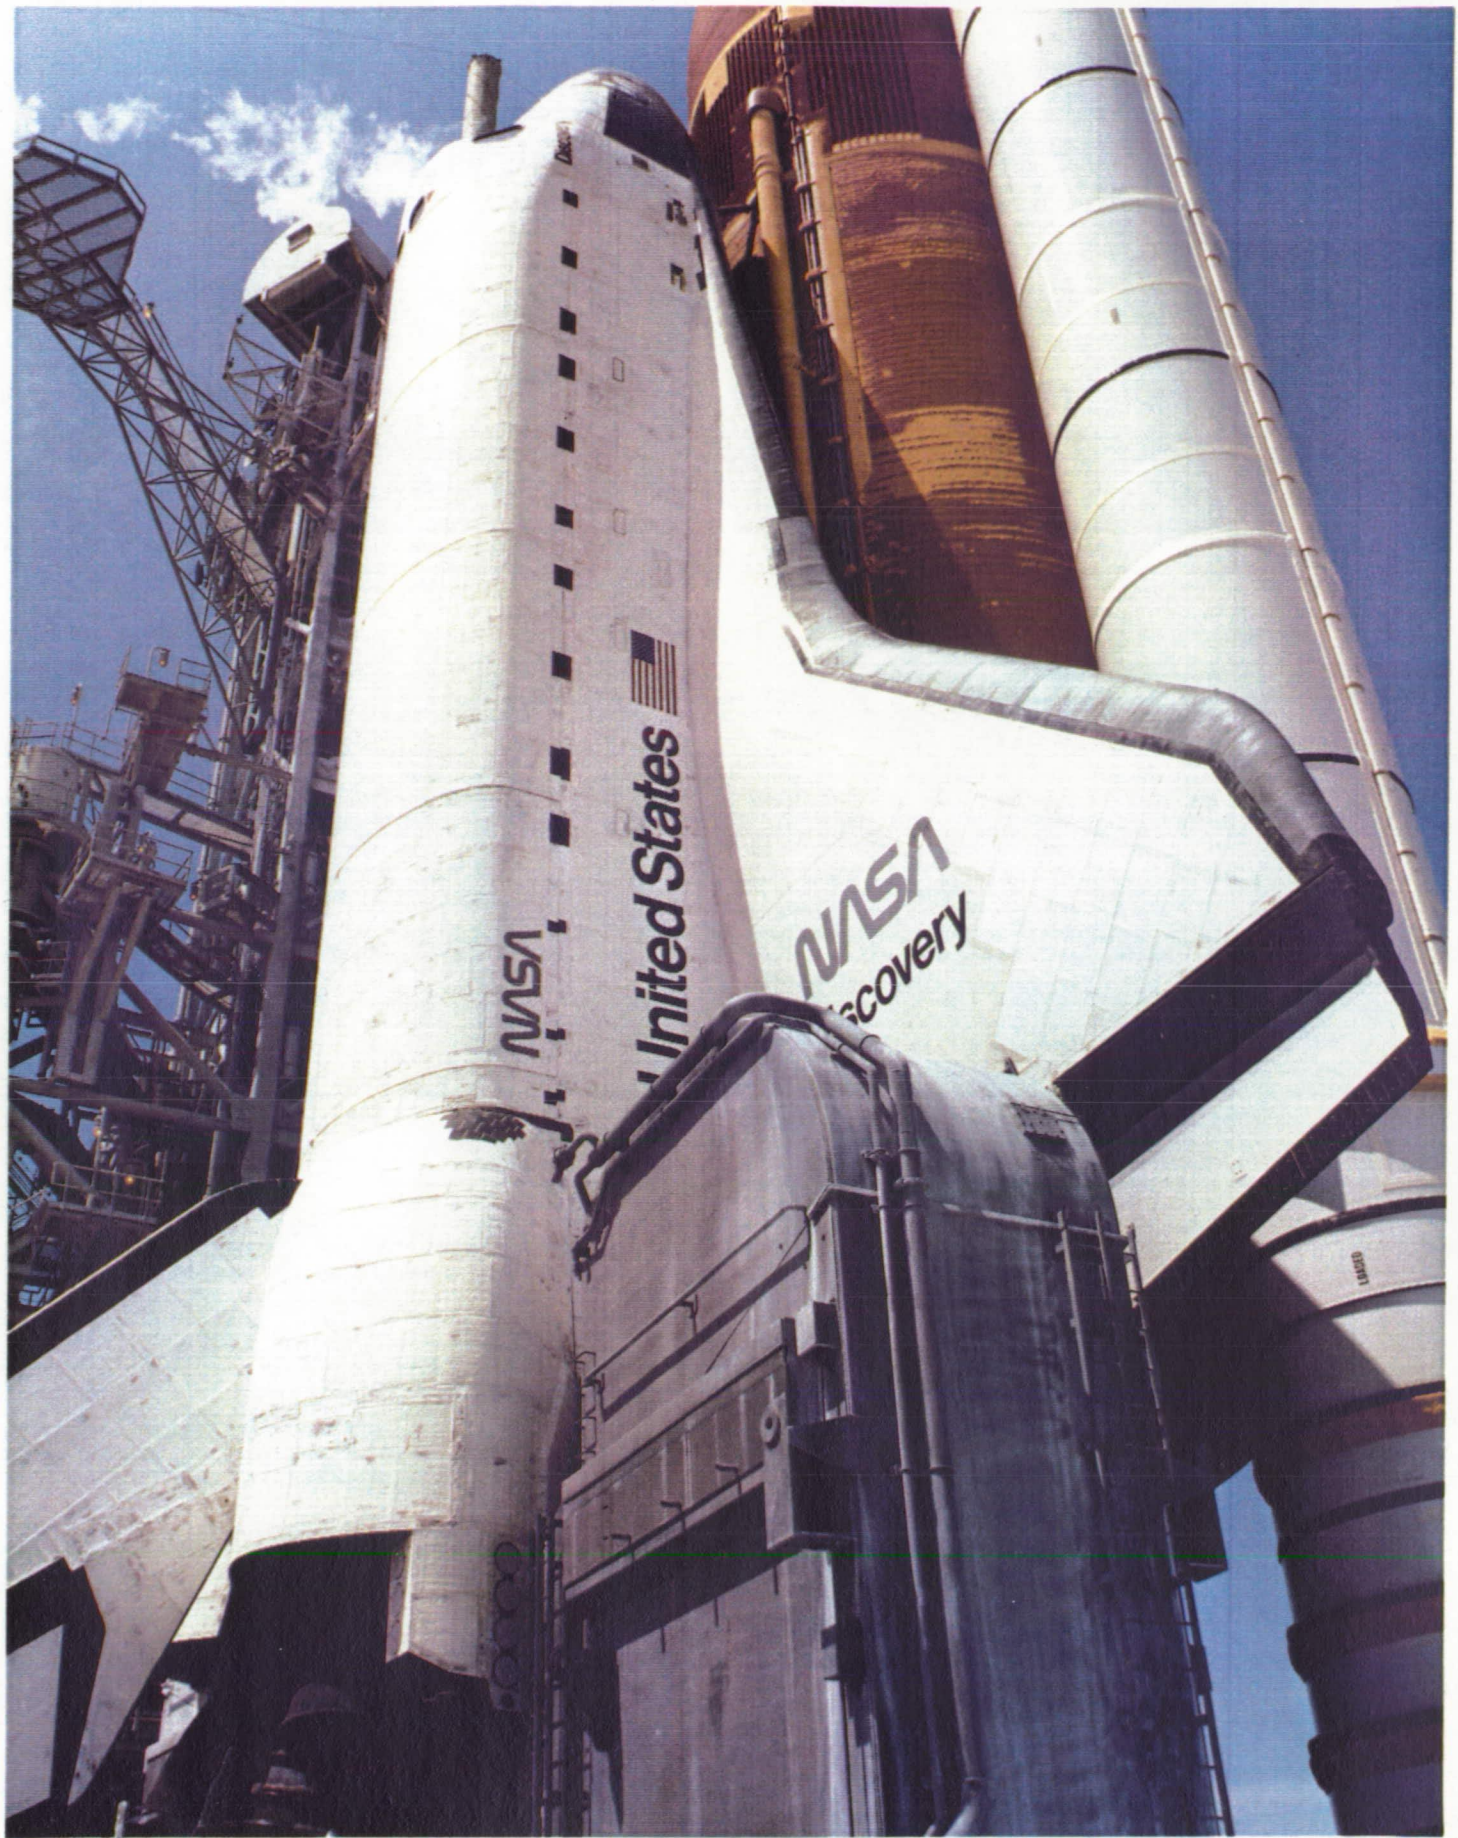
Overall view of OV-103, ET-42 (LWT 35), and BI-046 SRB's

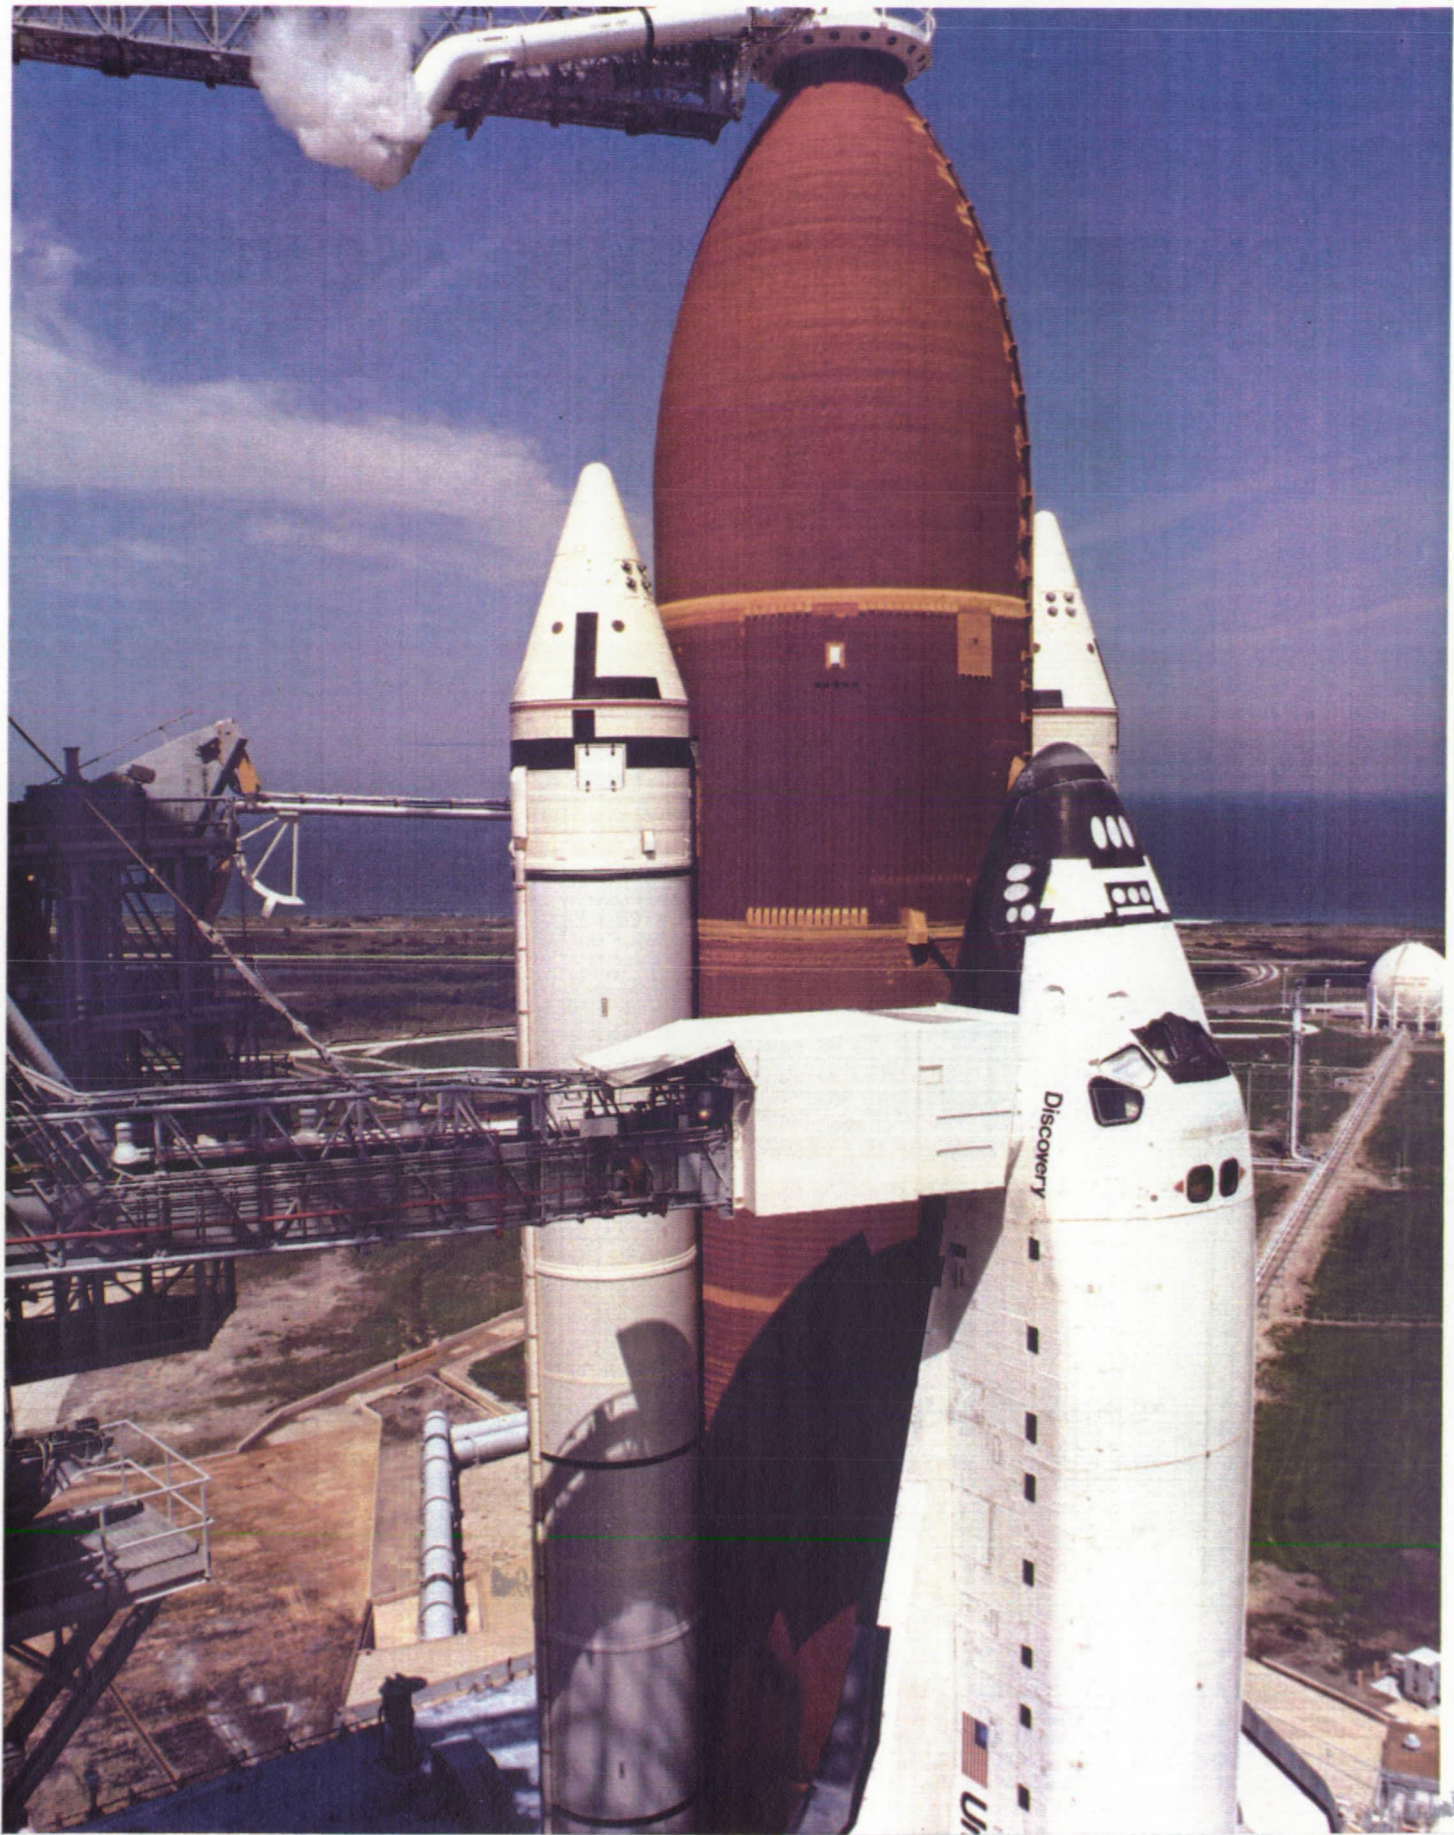
There were no TPS anomalies or ice/frost accumulations on the
External Tank acreage

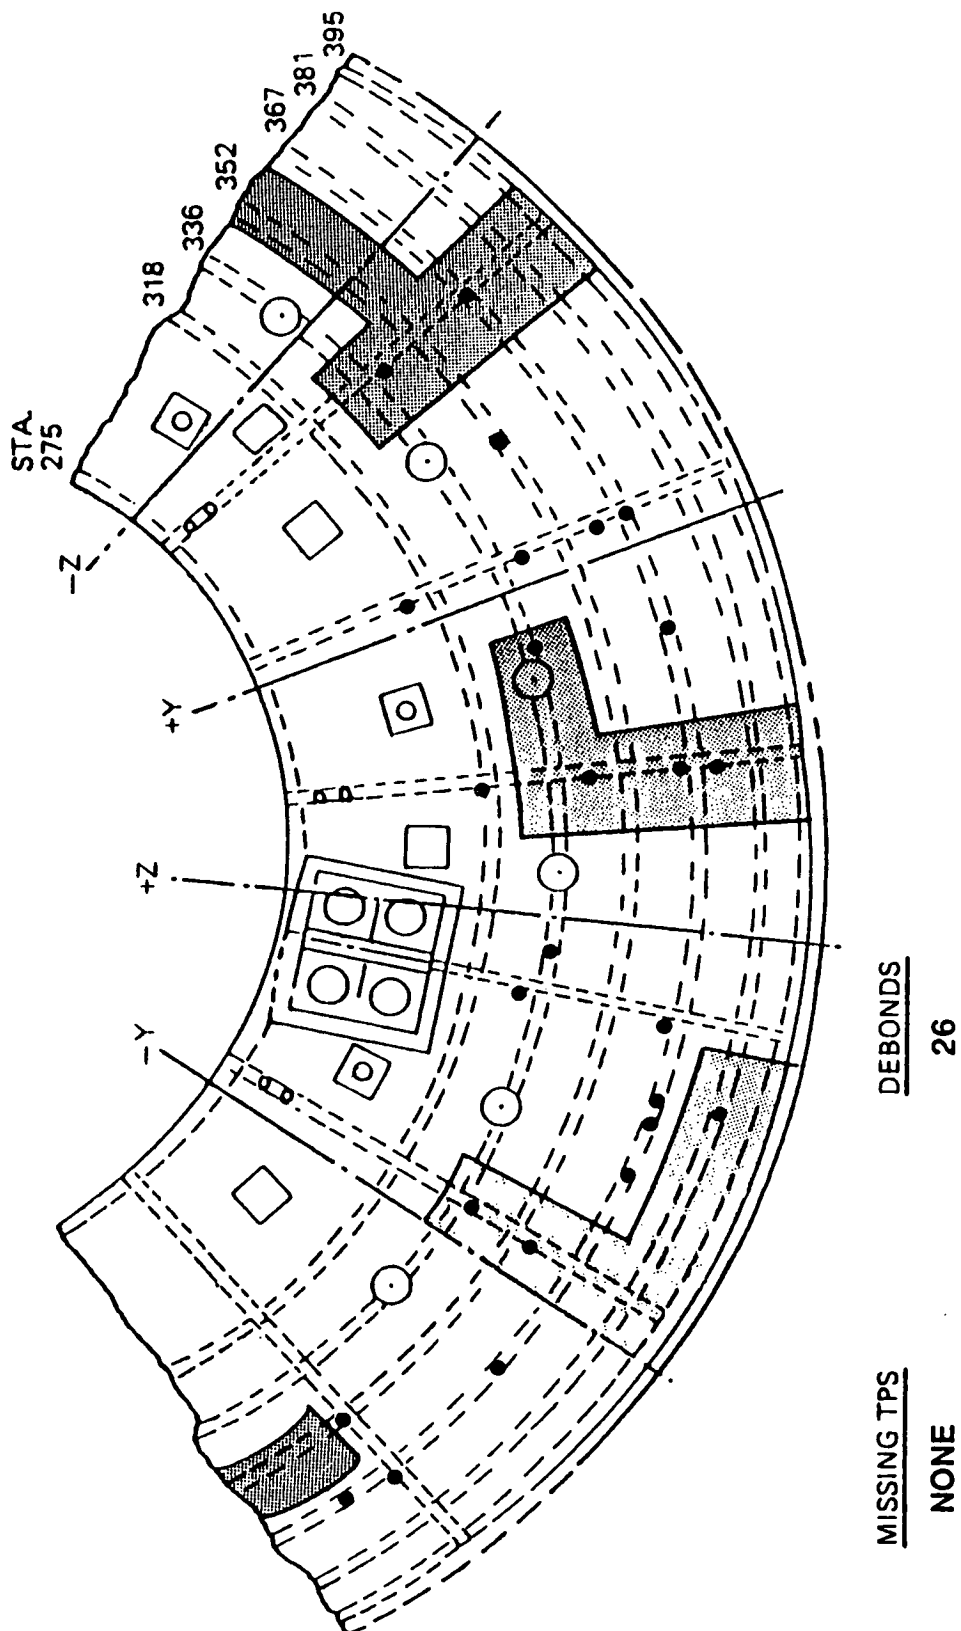
FIGURE 5. RIGHT SRB FRUSTUM

The RH frustum had no areas of missing TPS but had 26 MSA-2 debonds over fasteners. There was minor localized blistering of the Hypalon paint (Figure 5). All BSM covers were locked in the fully opened position.

The RH frustum was missing no TPS but had 26 MSA-2 debonds over fasteners.

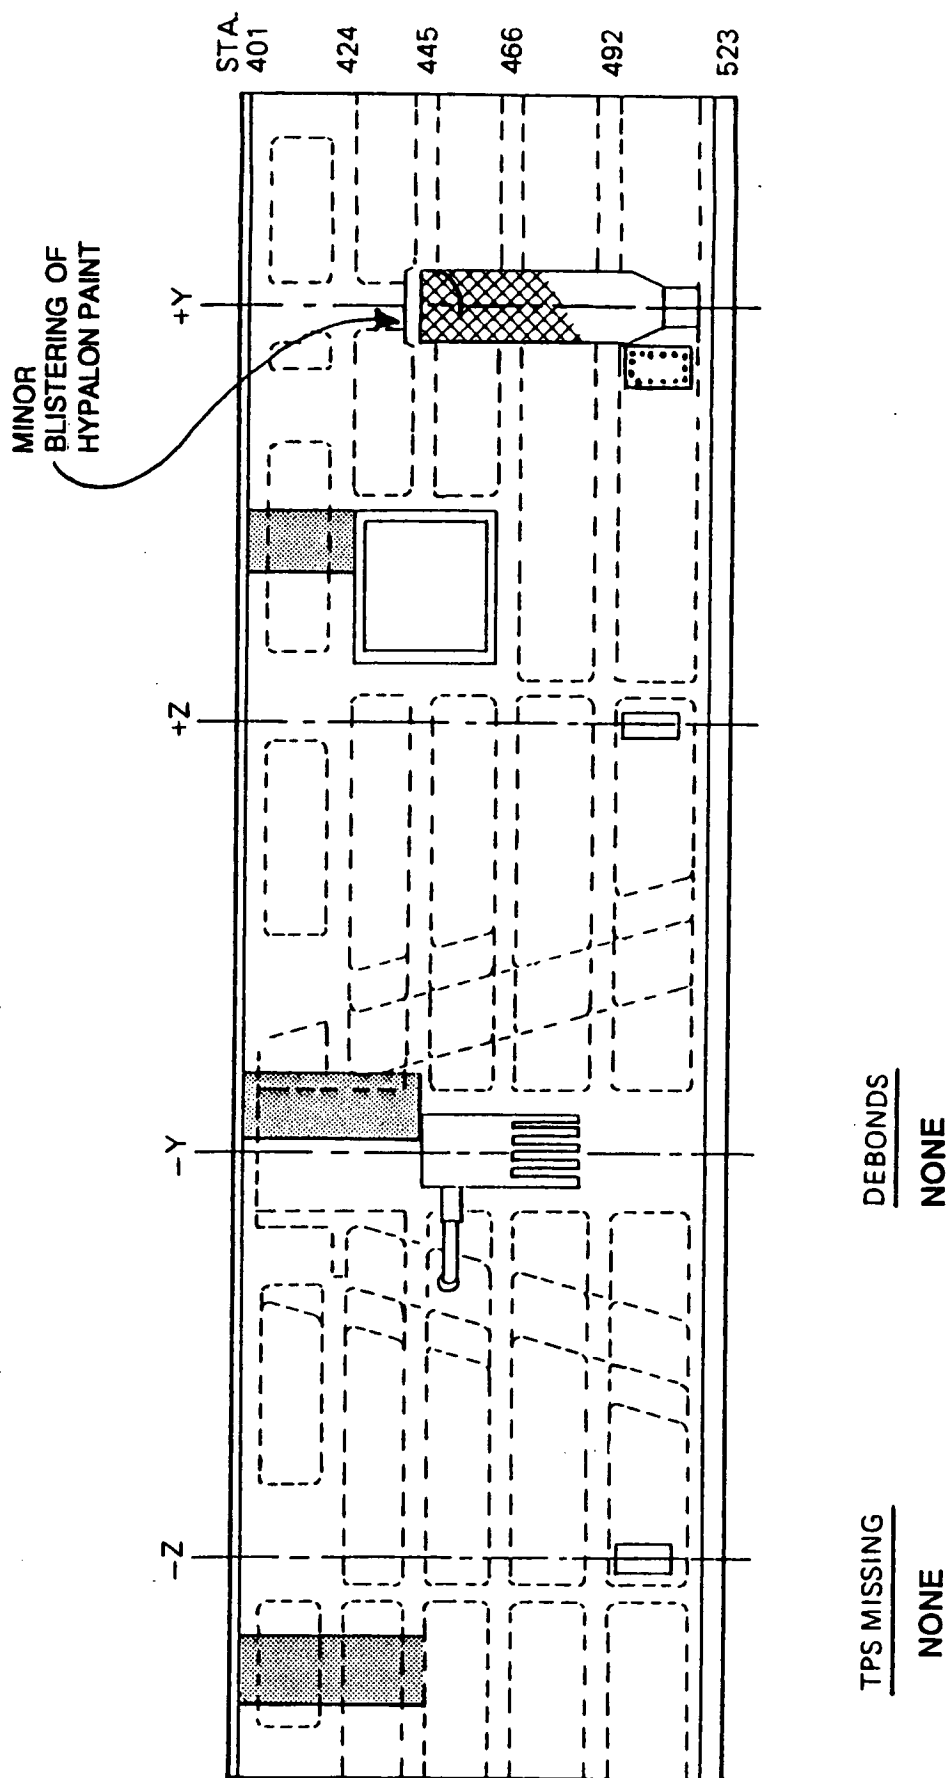
FIGURE 6. RIGHT SRB FWD SKIRT

The RH forward skirt exhibited no debonds or missing TPS. The phenolic plates on both RSS antennae were intact. The forward separation bolt and electrical cables appeared to have separated cleanly. No pins were missing from the frustum severance ring. Minor blistering of the Hypalon paint occurred forward of the ET/SRB attach point (Figure 6).

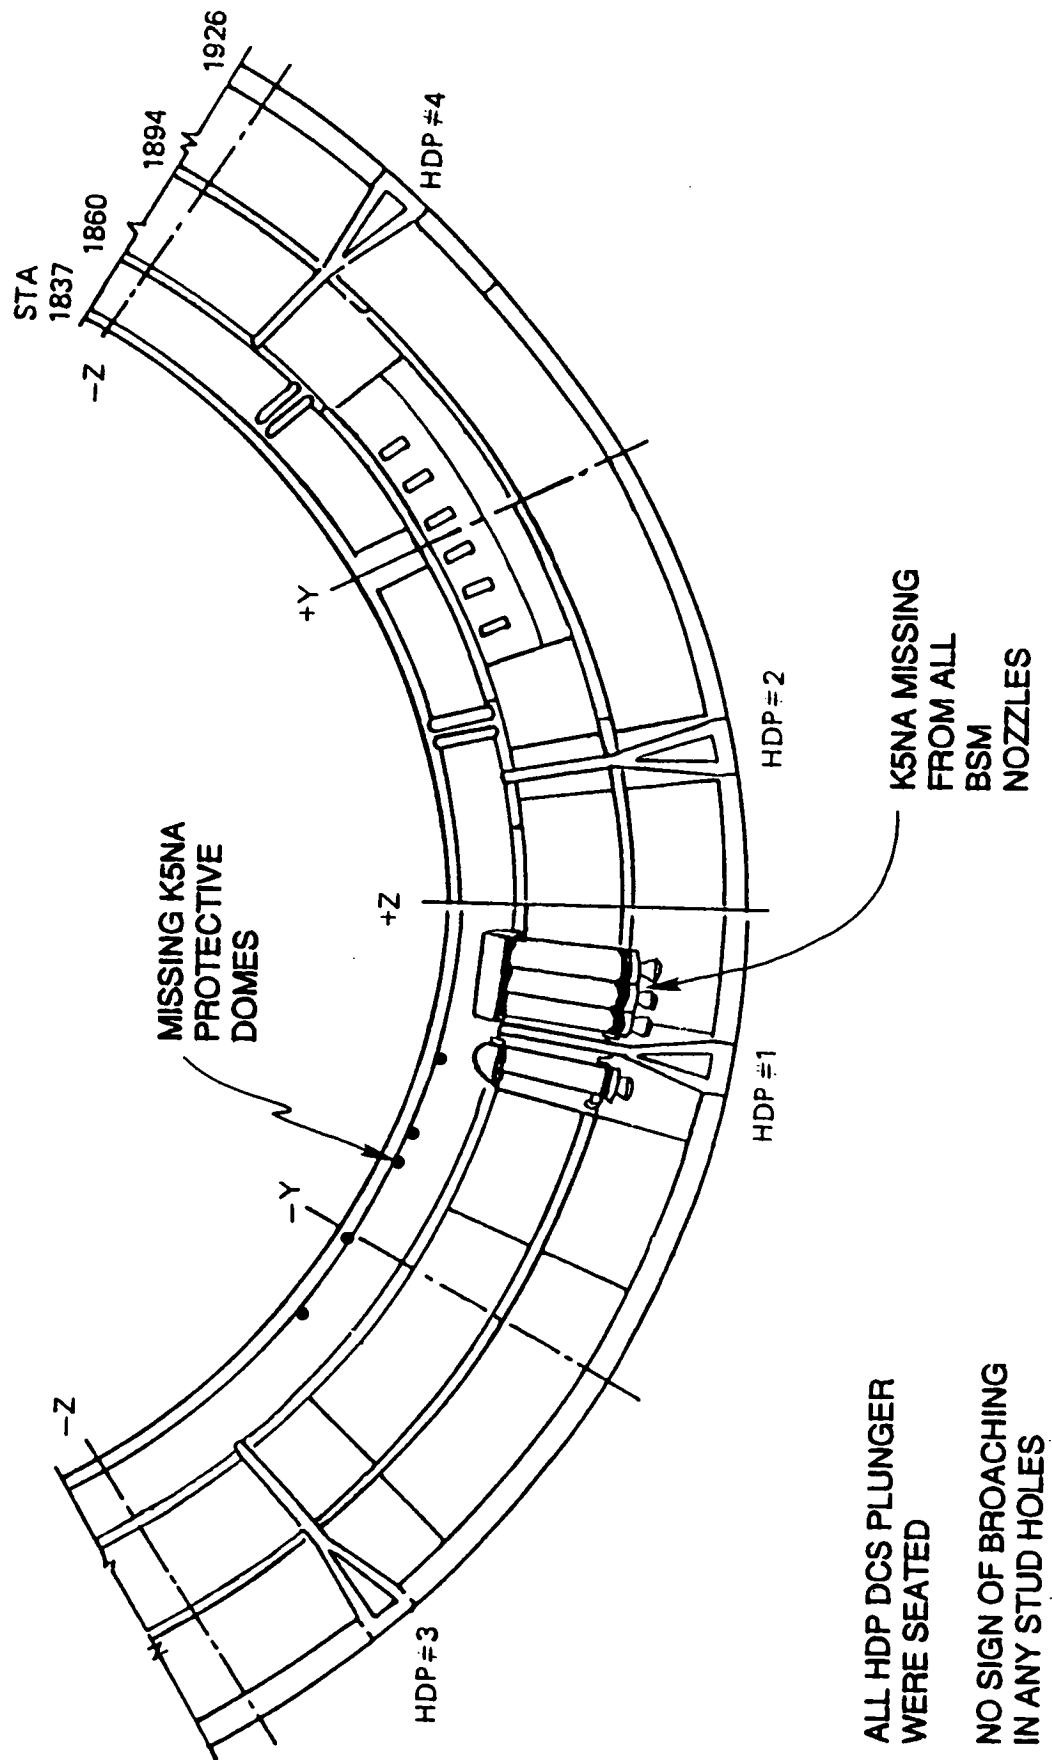
FIGURE 7. RIGHT SRB AFT SKIRT EXTERIOR TPS

The phenolic material on the kick ring was delaminated. Five K5NA protective domes between HDP #1 and #3 were lost from bolt heads on the aft side of the phenolic kick ring prior to water impact (sooted substrate). The aft skirt acreage TPS was in good condition (Figure 7). K5NA was missing from all aft BSM nozzles.

All four HDP Debris Containment System (DCS) plungers were seated. This was the third flight utilizing the optimized link. There was no sign of broaching in any of the stud holes. HDP #3 and HDP #4 EPON shim sidewall material was lost prior to water impact. MSFC will review the bonding process.

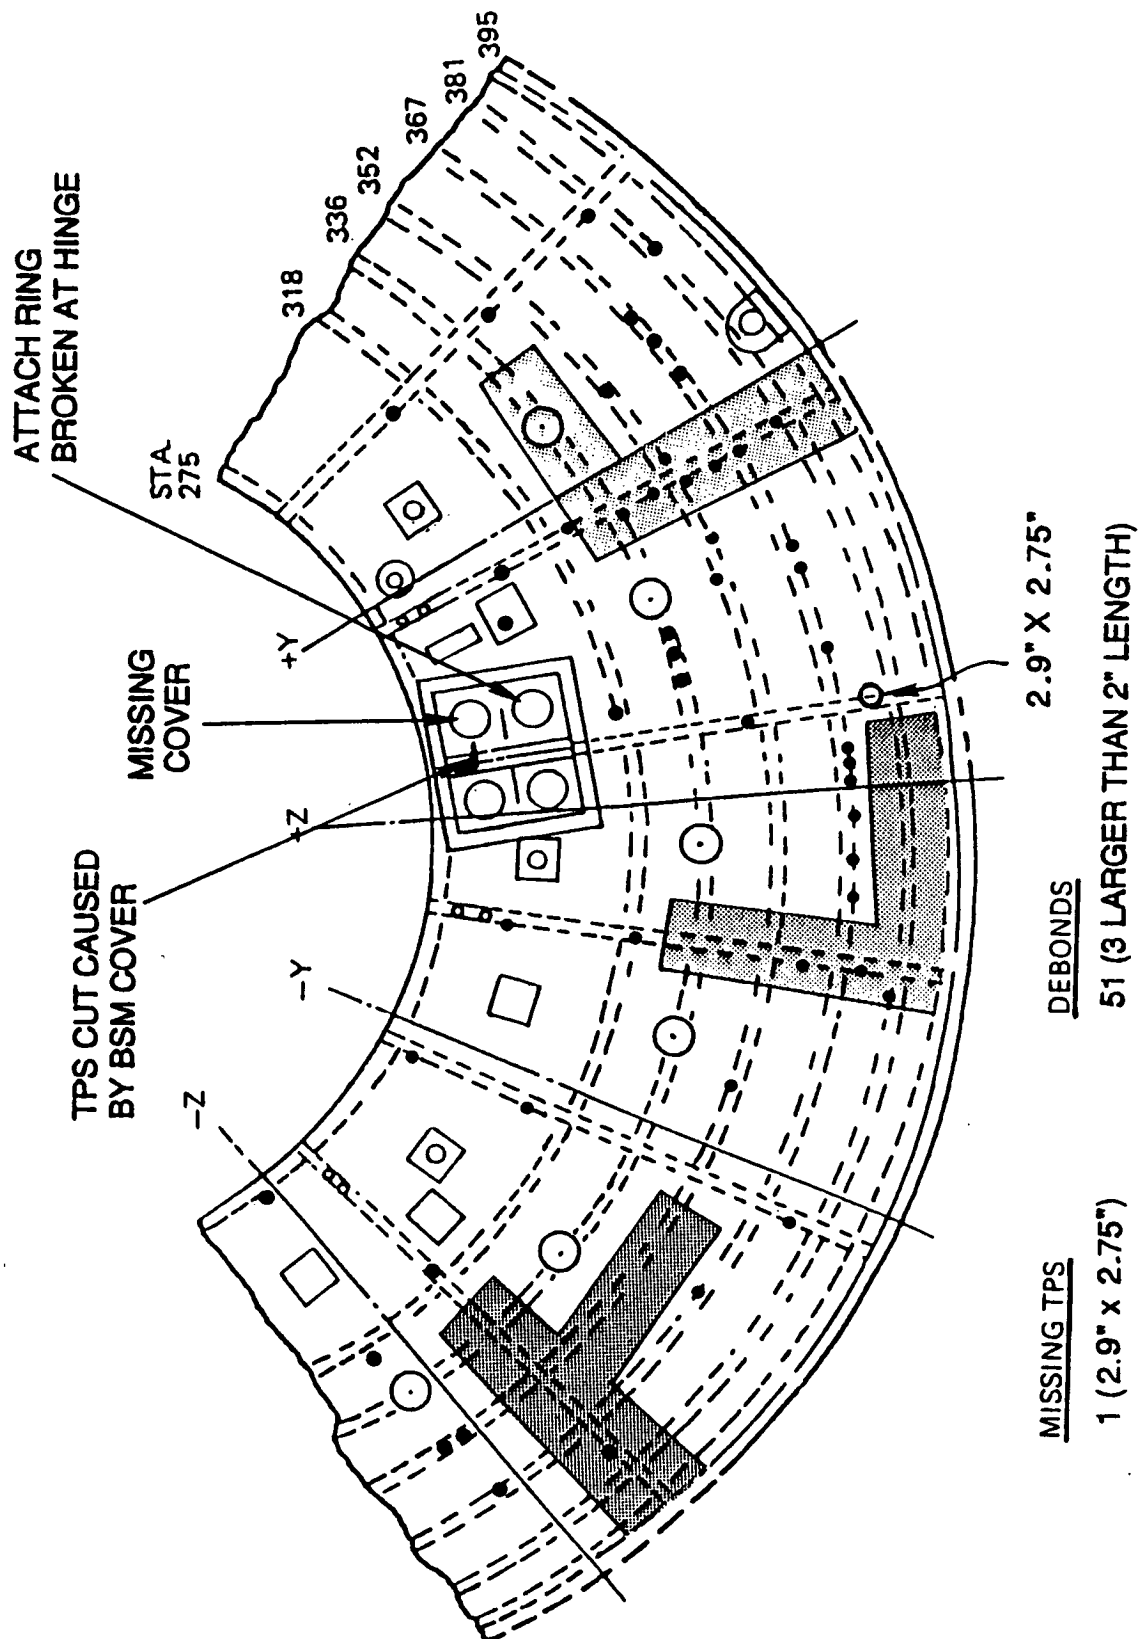
FIGURE 8. LEFT SRB FRUSTUM

A 2.9" x 2.75" area of MSA-2 was missing from the LH frustum on the stiffener below the BSM's near the 381 ring. A laboratory analysis was performed at MSFC on the MSA-2 divot area. Examination of the surrounding material showed that the exposed surfaces were clean and free of sooting/charring/ heat effects in an aero-thermal environment. Hypalon peelback occurred laterally and was not in the direction of the nosecone (forward flight). The report concluded the MSA-2 was lost either during the late stages of descent, at water impact, or during retrieval operations.

The LH frustum had 51 MSA-2 debonds over fasteners (Figure 8). A 2.9"x2.75" area of MSA-2 was missing from two fasteners on the stiffener below the BSM's near the 381 ring. The MSA-2 had separated completely from the substrate. The MSA-2 fracture edges and surrounding Hypalon paint were not sooted/charred, the exposed MSA-2 material was clean, and no unusual heating effects were visible. Samples were taken for laboratory analysis at MSFC. There was minor localized blistering of the Hypalon paint on the acreage areas of the frustum.

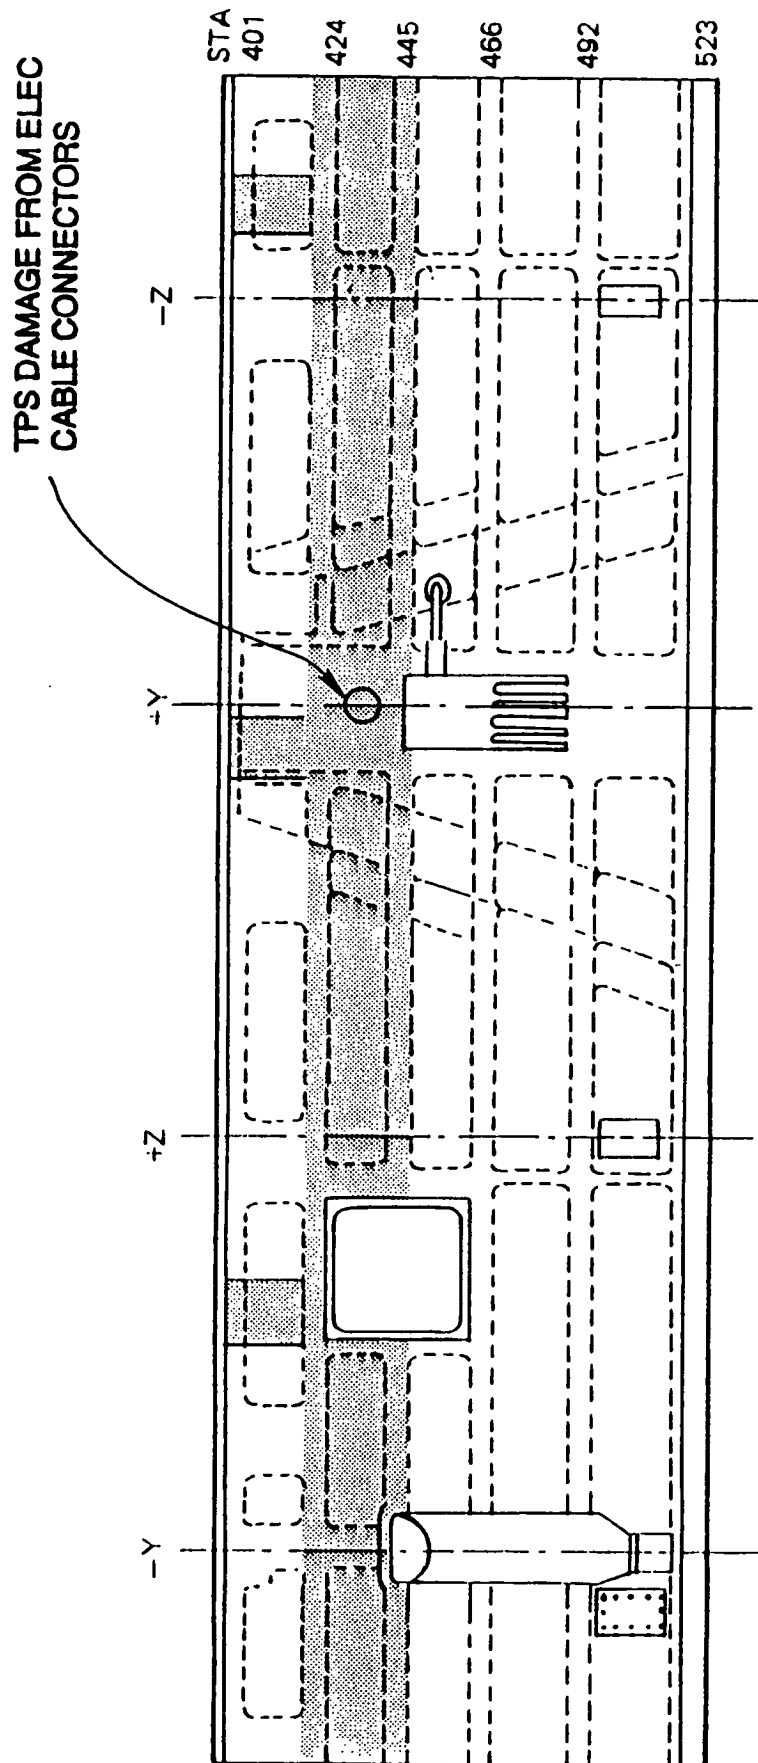
FIGURE 9. LEFT SRB FWD SKIRT

The LH forward skirt exhibited no debonds or missing TPS. The phenolic plates on both RSS antennae were intact. The forward separation bolt and electrical cables appeared to have separated cleanly. No pins were missing from the frustum severance ring. Minor blistering of the Hypalon paint occurred forward of the ET/SRB attach point (Figure 9).

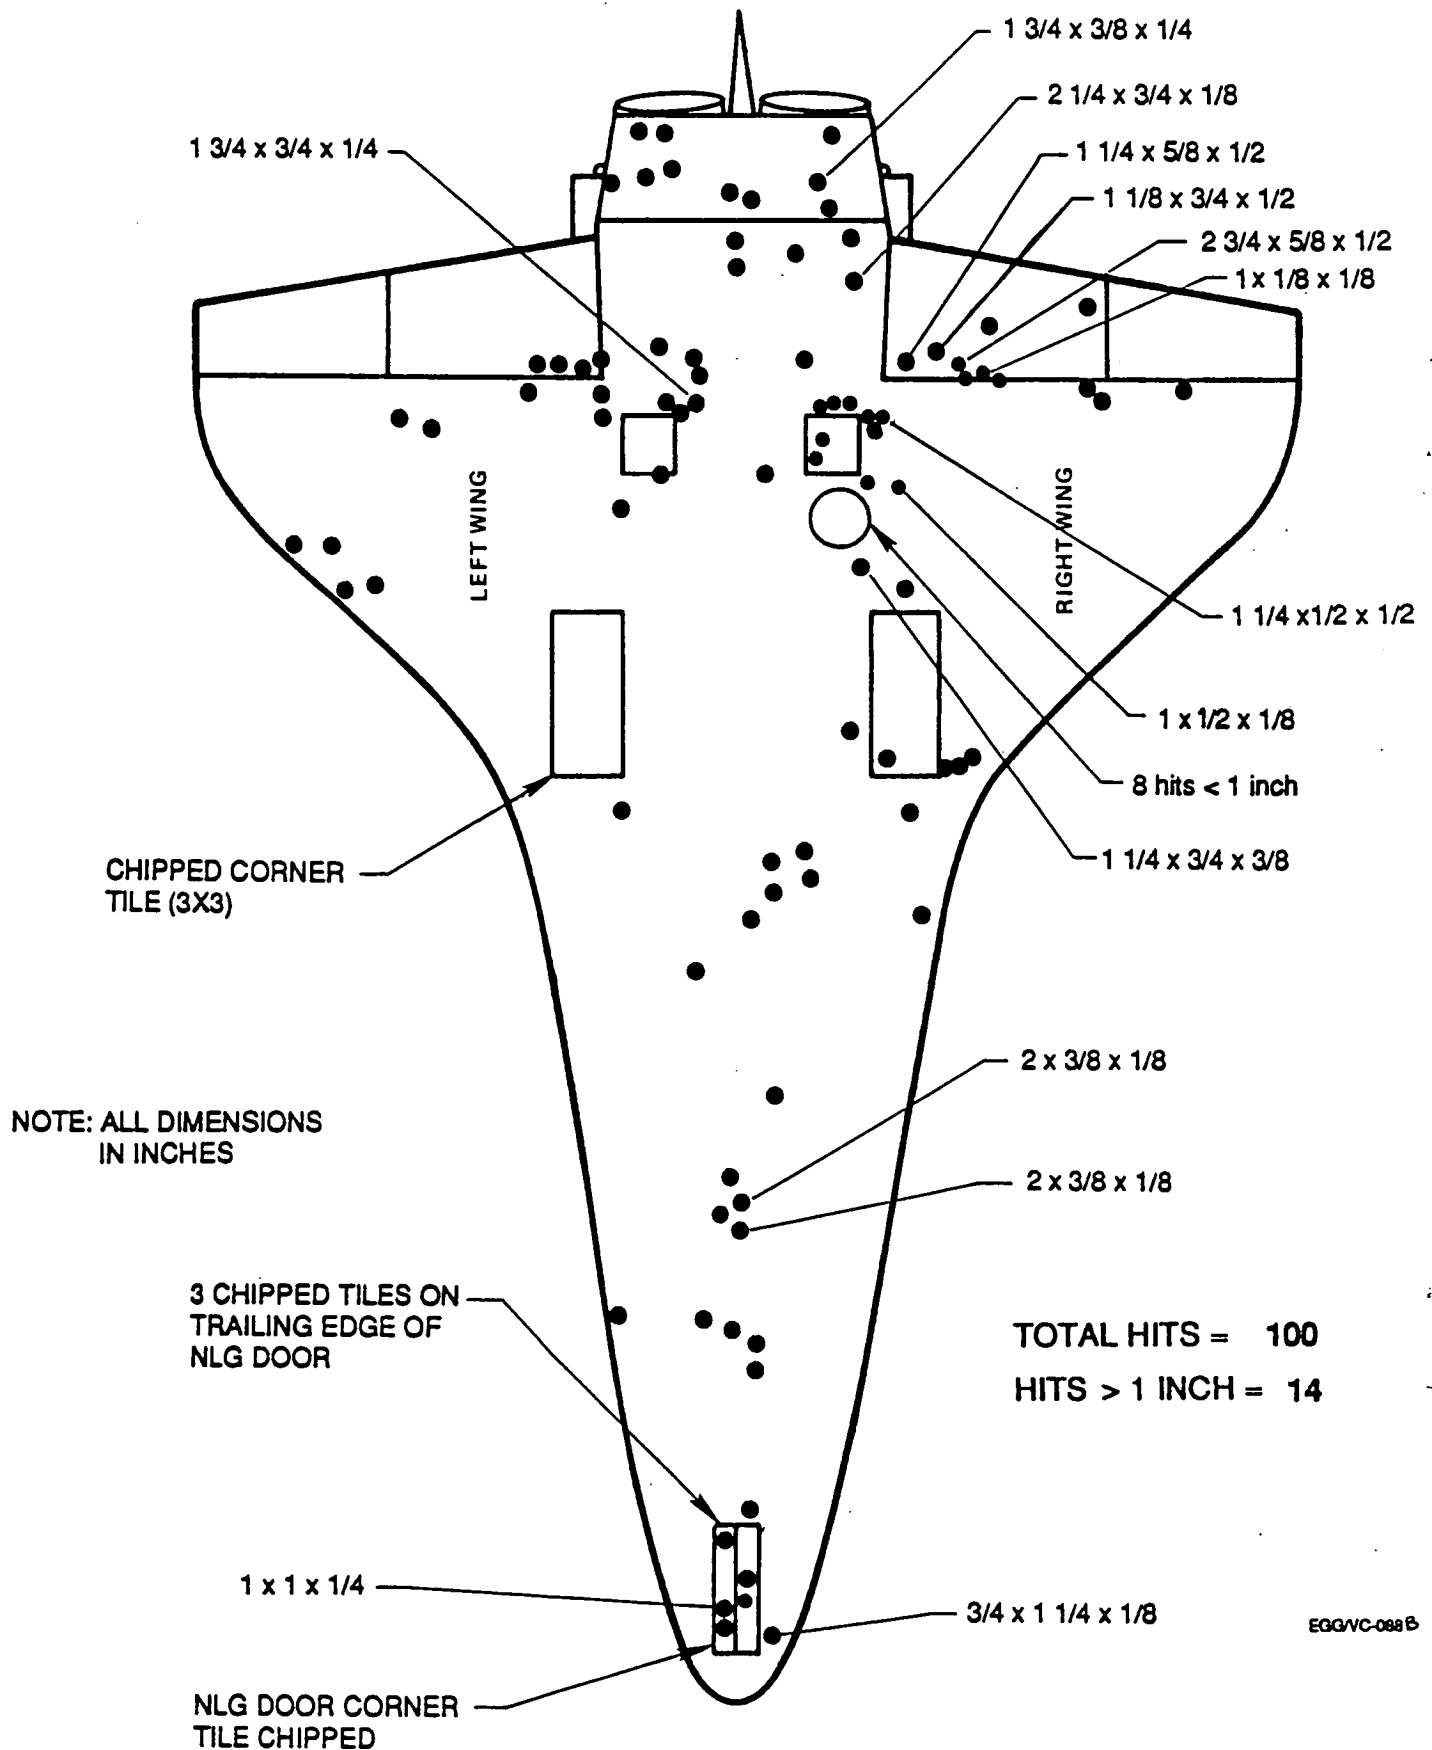
FIGURE 11. **DEBRIS DAMAGE LOCATIONS**

The Orbiter lower surface had a total of 100 hits of which 14 had a major dimension of one inch or greater. A comparison of these numbers to statistics from 30 previous missions of similar configuration (excluding missions STS-24, 25, 26, 26R, 27R, and 30R which had damage from known debris sources), indicates that the total number of hits was slightly greater than average and the number of hits one inch or larger was slightly less than average. Figures 11 - 14 map the TPS debris damage for STS-48.

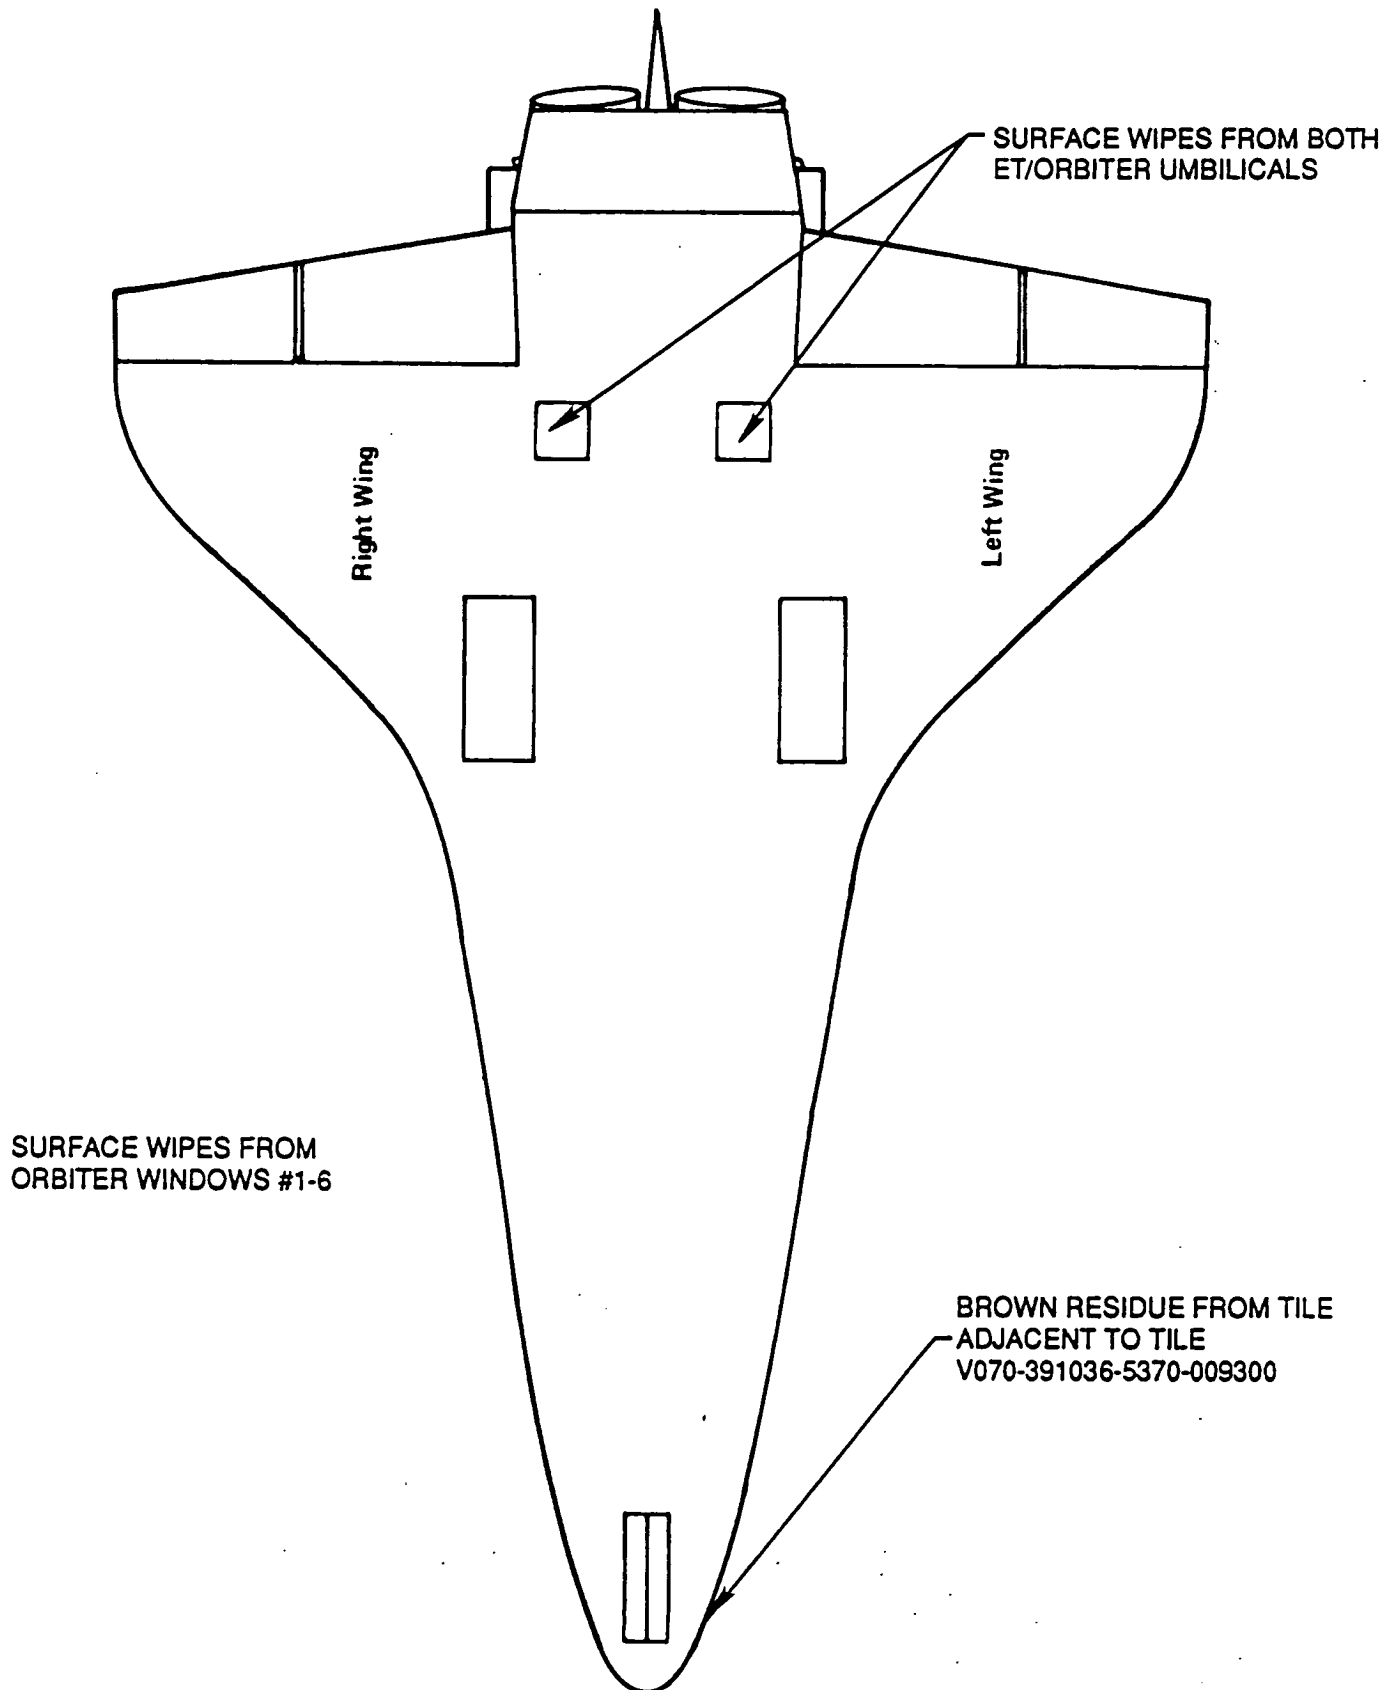
FIGURE 15.

Orbiter windows #1, #2, #5, & #6 were lightly hazed. Windows #3 and #4 exhibited moderate to heavy hazing and had numerous streaks. Laboratory analysis was performed on samples taken from all windows (reference Figure 15 and Section 9.0).

A total of 13 samples were obtained from Orbiter OV-103 during the STS-48 post landing debris assessment at Ames-Dryden Flight Research Facility (ADFRF), California (Figure 15). The 13 submitted samples consisted of 8 Orbiter window wipes (W1-8), 1 tile residue sample, and 4 samples from the LOX and LH2 ET/Orbiter umbilicals. The samples were analyzed by the NASA KSC Microchemical Analysis Branch (MAB) for material composition and comparison to known STS materials. Debris analysis involves the placing and correlating of particles with respect to composition, thermal (mission) effects, and availability. Debris sample results and analyses are listed by Orbiter location in the following summaries.
